NAVAL SURFACE WEAPONS CENTER DAHLGREN LAB
HIGH STRENGTH ALUMINUM CASTING TECHNOLOGY: SQUEEZE CASTING OF 7--ETC(U)
OCT 77 J R THOMPSON
NSWC/DL-TR-3744

4. TITLE (and Subtitle) High Strength Aluminum Casting Technology: Squeeze Casting of 7075 Alloy.		5. TYPE OF REPORT & PERIOD COVERED Final rept.,
7. AUTHOR(s) J. R. Thompson, Jr.		6. PERFORMING ORG. REPORT NUMBER (17)

9. PERFORMING ORGANIZATION NAME AND ADDRESS Naval Surface Weapons Center (DG-30) Dahlgren Laboratory Dahlgren, Virginia 22448		10. PROGRAM ELEMENT, PROJECT, TASK AREA & WORK UNIT NUMBERS a. 64606M CAW01026, DG68- b. 62332N SF32343302 DG68

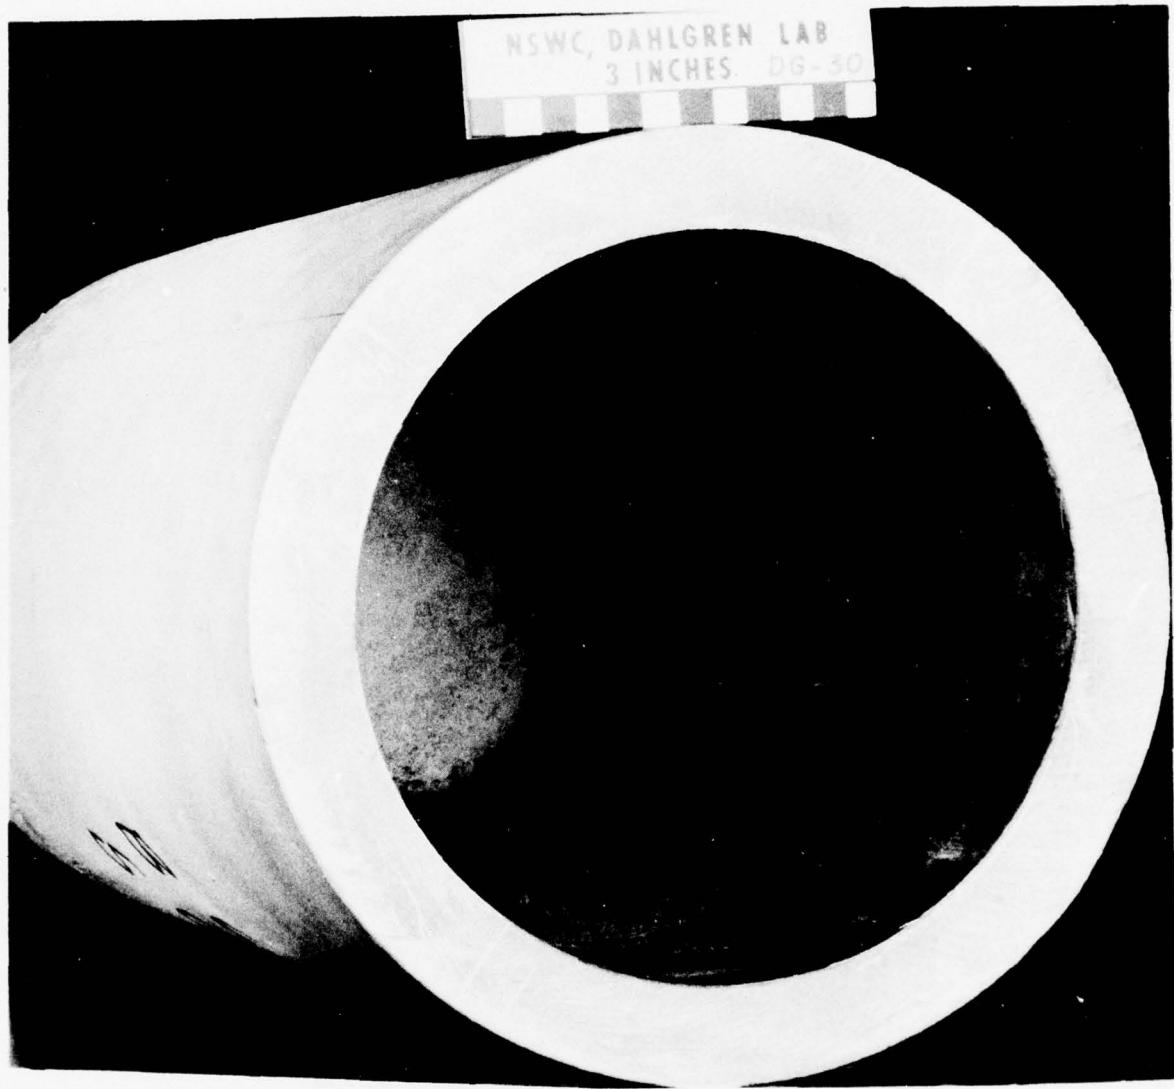
FIGURE 2. AS-RECEIVED CONDITION OF SQUEEZE CAST CYLINDER SC-9.

Photographic documentation of the as-received cylinders is presented in Figures 1 through 6. The lower quarter exterior surface of both cylinders (near the closed ends) was quite rough; the face of the closed ends was equally rough. This surface roughness appears to be related to non-optimum tooling design and could be corrected without difficulty. The scribe marks in Figures 1, 2, 4, and 5 were made by NSWC personnel to indicate locations for dimensional inspection. Figures 3 and 6 show the interior surfaces of the cylinders to be relatively smooth except for some tool marks at the open end.

Exterior View at 180°

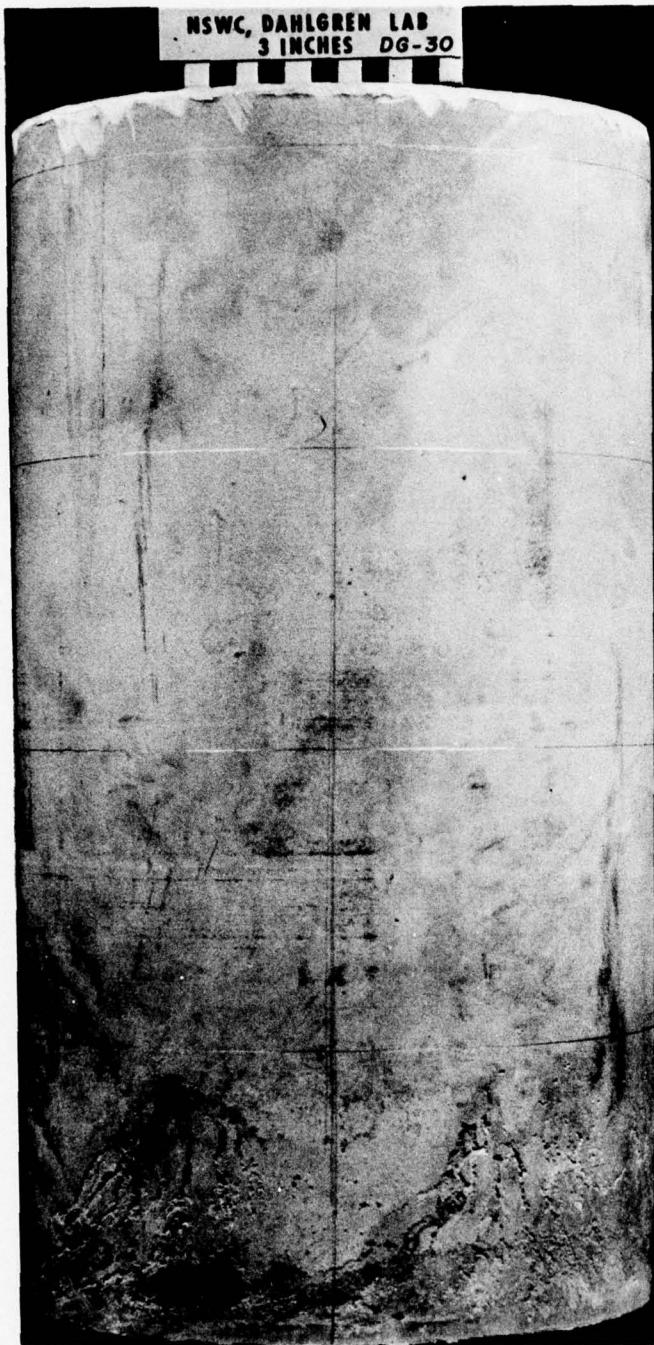
FIGURE 4. AS-RECEIVED CONDITION OF SQUEEZE CAST CYLINDER SC-10.

Exterior View at 90°

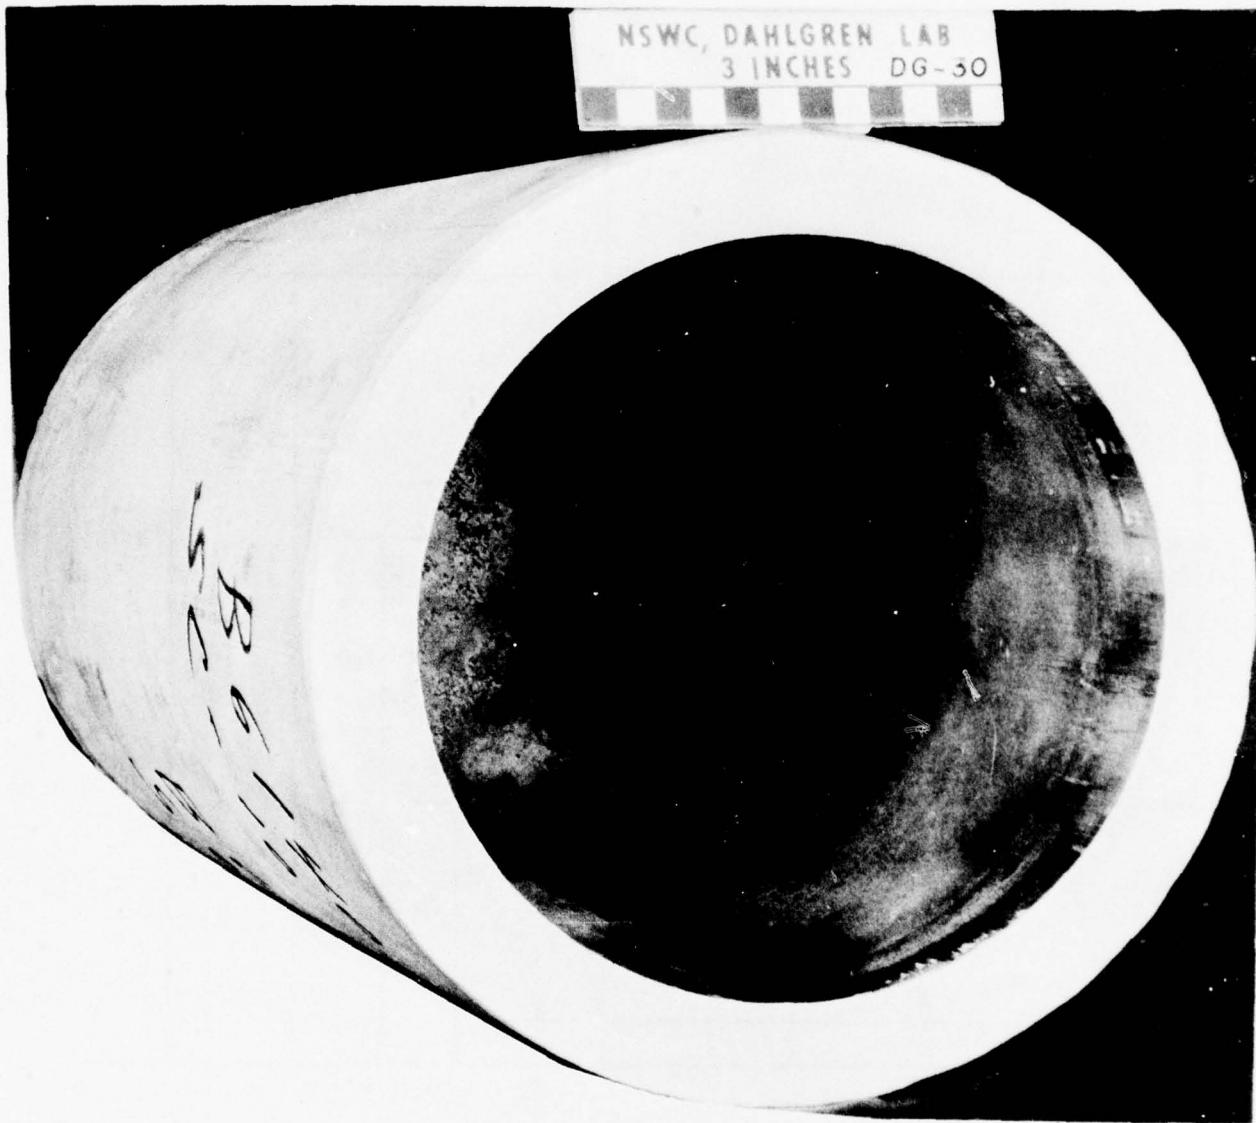
FIGURE 5. AS-RECEIVED CONDITION OF SQUEEZE CAST CYLINDER SC-10.

Exterior View at 270°

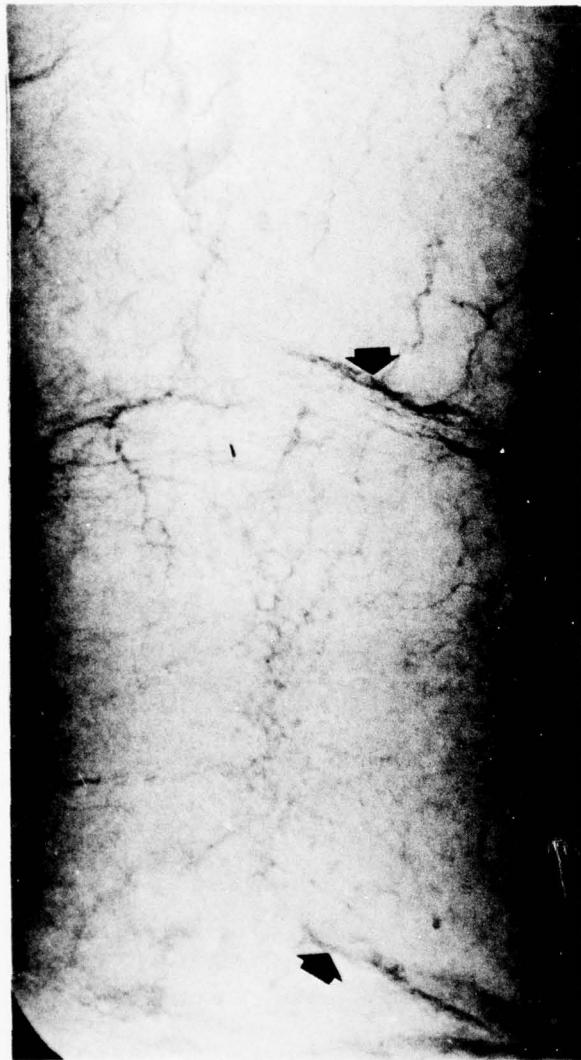
Both cylinders were machined without difficulty to the dimensions in Table 3 and reinspected by X-ray radiography and ultrasonic C-scan methods. Radiographic procedures were the same as used in the initial inspection. The solid bases on both cylinders looked fairly sound although a limited amount of small scale porosity was detected. Radiographic data for the sidewalls was similar to that for the as-received conditions. Cylinder SC-9 showed a "pattern" of dense areas in the walls; Figure 8 is a print from a radiograph illustrating this "pattern". Visual examination of the cylinder cavity surface did not provide an indication of the cause of this characteristic. Cylinder SC-10 showed the same behavior as SC-9 except that this "pattern" was more noticeable near the open end of the cylinder. The cause of these "patterns" was thought to be a localized variation in chemical composition of the aluminum alloy or the presence of a high density second phase rather than cracks and porosity. Cracks and porosity would allow greater X-ray penetration and would show up on the radiographs as dark areas and lines (white or light on a print such as Figure 8). A localized high-density material would decrease X-ray penetration and show up a light area on the radiographs (dark on a print). The latter behavior was observed. No reason for the presence of high density regions in the cylinders could be found at this time.

SC-9 225°

SC-10 45°

FIGURE 8. TYPICAL LOCALIZED HIGH DENSITY MATERIAL "PATTERNS" DETECTED IN SQUEEZE CAST CYLINDERS BY X-RAY RADIOGRAPHY.

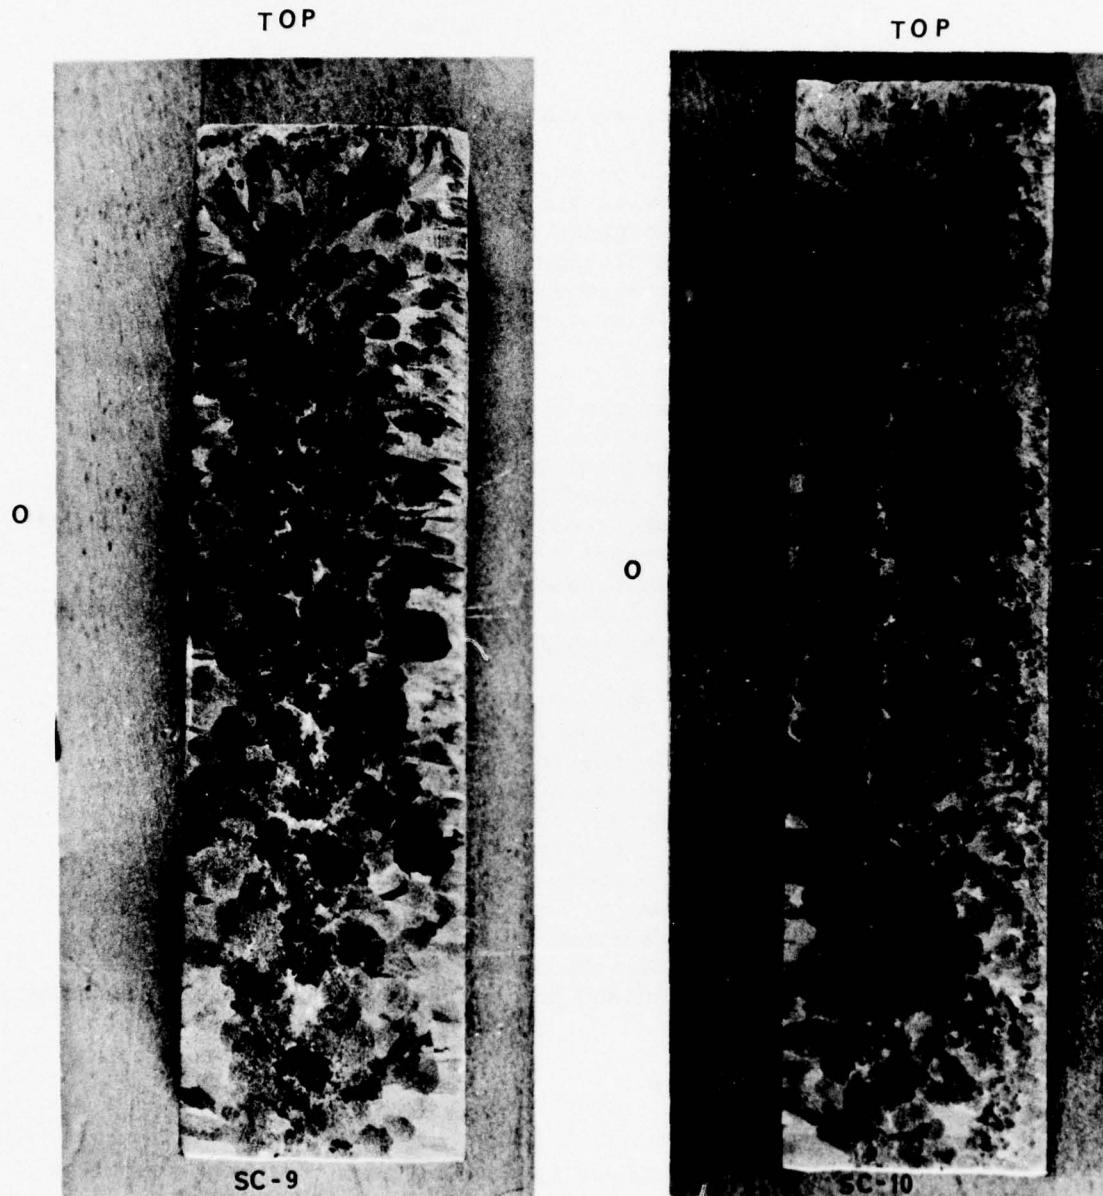
FIGURE 10. MACROSTRUCTURE OF TOP 2.5 INCHES OF SQUEEZE CAST 7075 ALUMINUM CYLINDERS.

Results of the macrostructure evaluation for the top 2.5 inches of the castings are shown in Figure 10. The structure is relatively coarse grained, with the structure on the inside being somewhat finer because of high-pressure contact with the punch part of the die system. A light colored, nearly continuous phase of unknown composition can be seen near the center of the cross section. This phase may be the source of the high-density material indications observed in the radiographs. The as-cast grain size of SC-10 is slightly finer than that of SC-9; no reason is readily apparent.

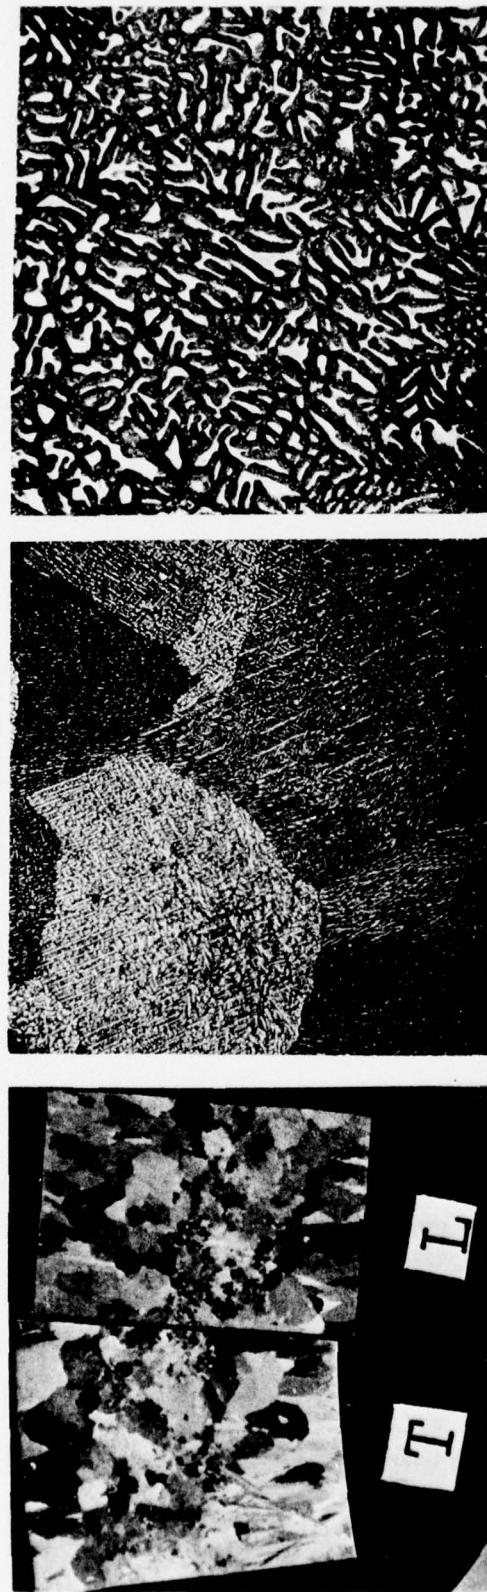
FIGURE 12. MICROSTRUCTURES OF SQUEEZE CAST 7075-F ALUMINUM ALLOY CYLINDER SC-9.

As-cast microstructures for each of the squeeze cast cylinders are presented in Figures 12 and 13. The extremely coarse grain size of these materials is very evident in the lower magnification photographs. This coarse grain structure should be replaced by a fine grain structure in order to develop optimum properties in the cast 7075 aluminum alloy. Chemical segregation or coring and some porosity can be seen in Figures 12c and 13c. Coring is typical for many casting alloys and is usually eliminated by homogenization annealing treatment or a solution annealing treatment. The porosity is not desired and was probably caused by entrapment of gases during solidification; tooling designed specifically for squeeze casting the desired guided projectile components would probably overcome this problem.

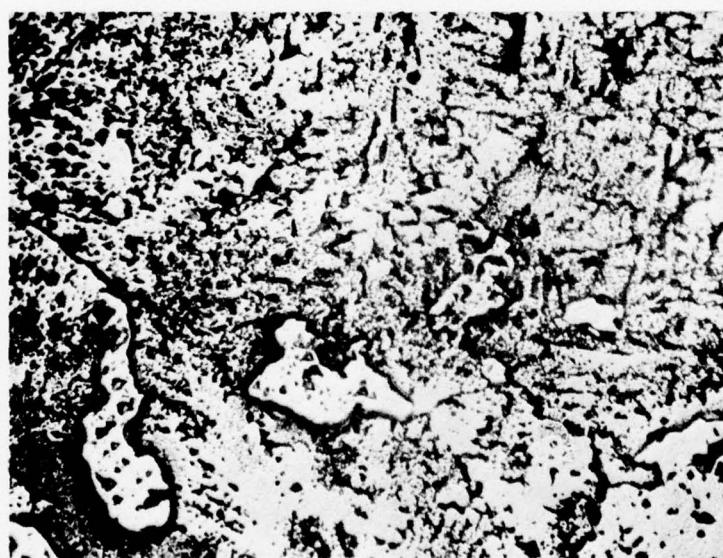
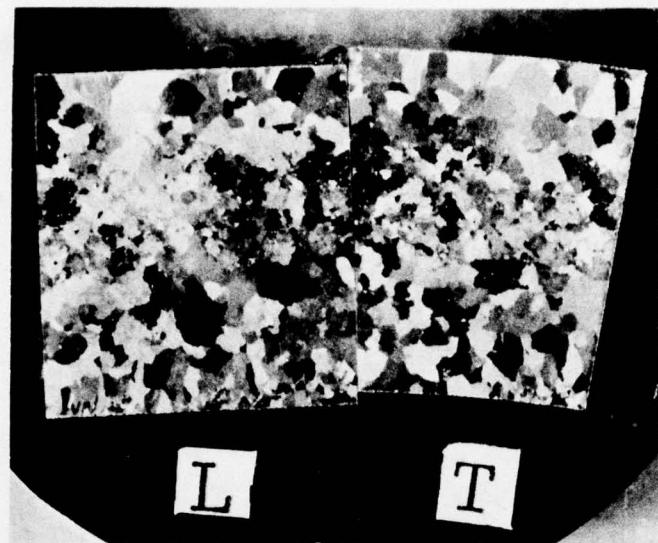
FIGURE 14. TYPICAL MICROSTRUCTURES FOR SQUEEZE CAST 7075 ALUMINUM ALLOY AFTER SOLUTION ANNEAL.

Figures 14 to 19 illustrate typical microstructures found in the 7075-W materials following the various solution annealing treatments. The low magnification photographs of the overall cross-sections still exhibit a coarse grain structure. The high magnification photographs reveal subgrain structures within the larger grains, some porosity at the subgrain and grain boundaries, some residual coring, and some precipitates or second phases which did not go into solid solution. Based on the hardness and microstructural data, it was decided that specimens 9B, 9C, 10B, and 10C should be precipitation hardened using the standard treatment for wrought 7075 alloy: $250 \pm 10^{\circ}\text{F}$ for 24 hours.

Specimen SC-9A heat treated at 905°F for 2 hours and water quenched.

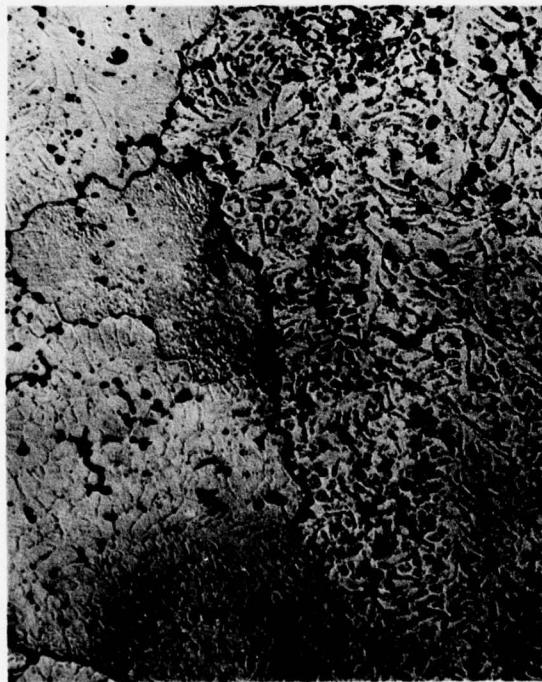
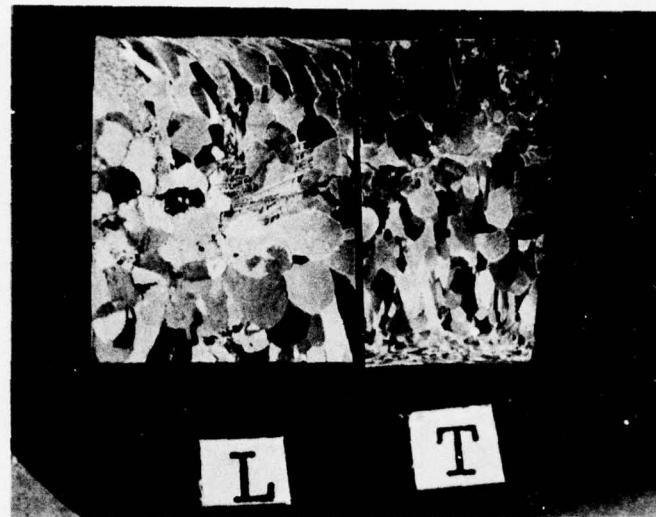
FIGURE 15. TYPICAL MICROSTRUCTURES FOR SQUEEZE CAST 7075 ALUMINUM ALLOY AFTER SOLUTION ANNEAL.

Specimen SC-9B heat treated at 905°F for 4 hours and water quenched.

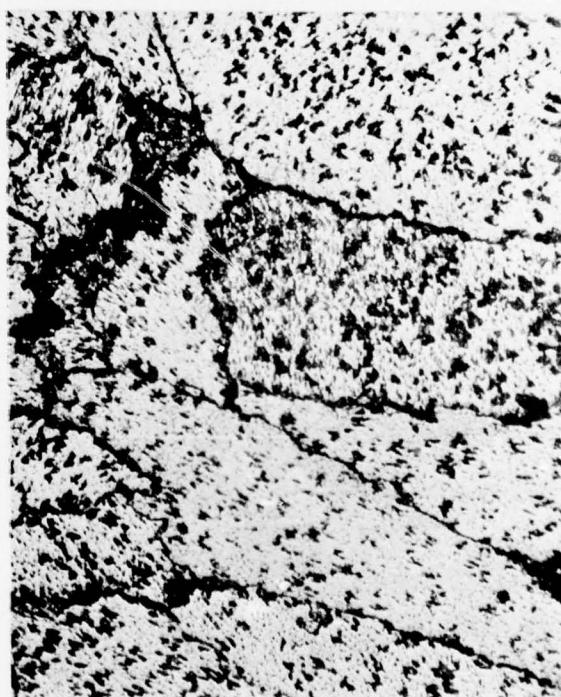
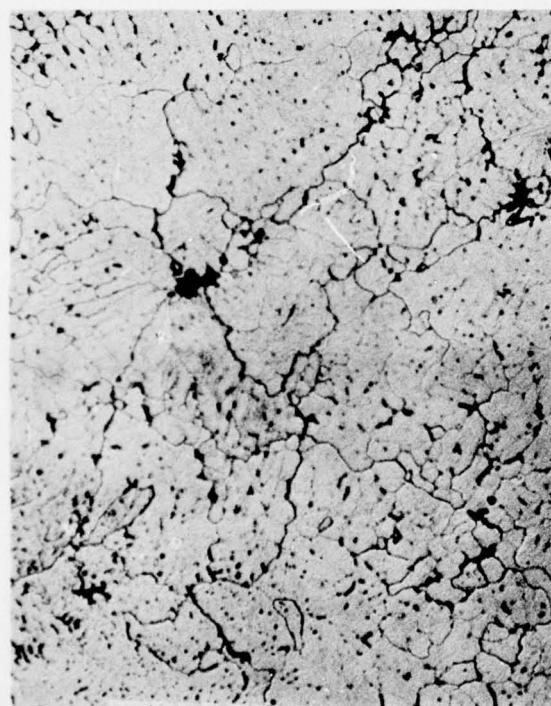
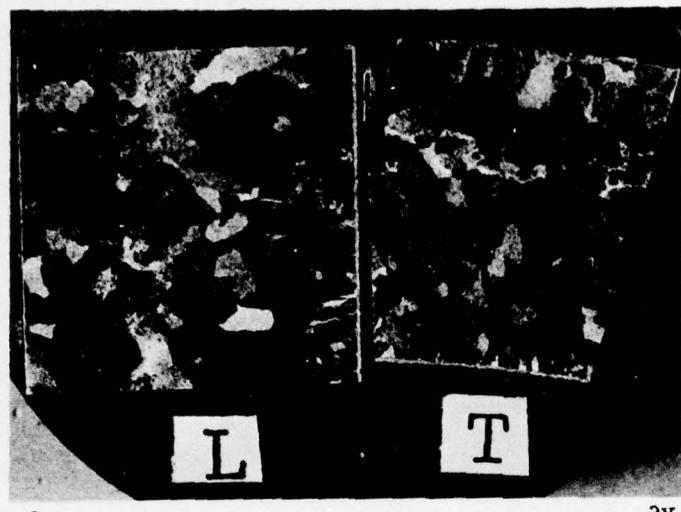
FIGURE 16. TYPICAL MICROSTRUCTURES FOR SQUEEZE CAST 7075 ALUMINUM ALLOY AFTER SOLUTION ANNEAL.

Specimen SC-10A heat treated at 870°F for 2 hours and water quenched.

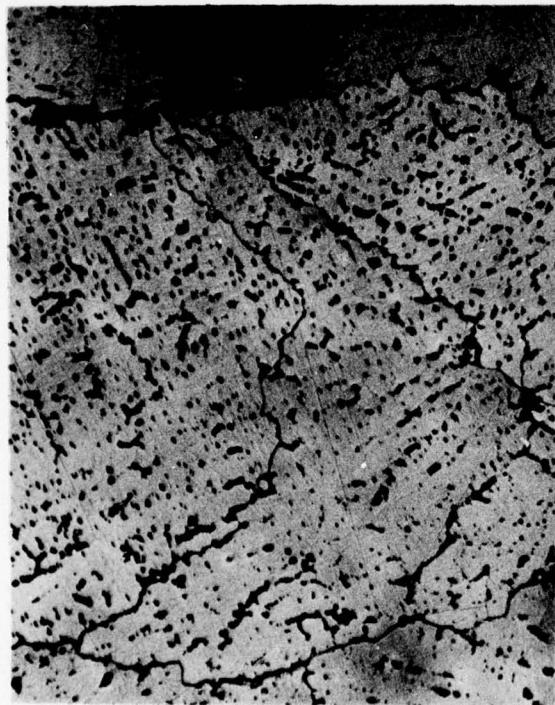
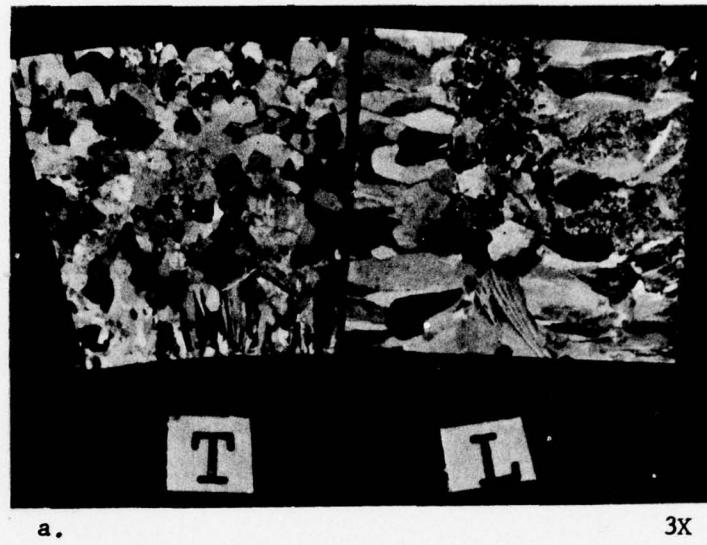
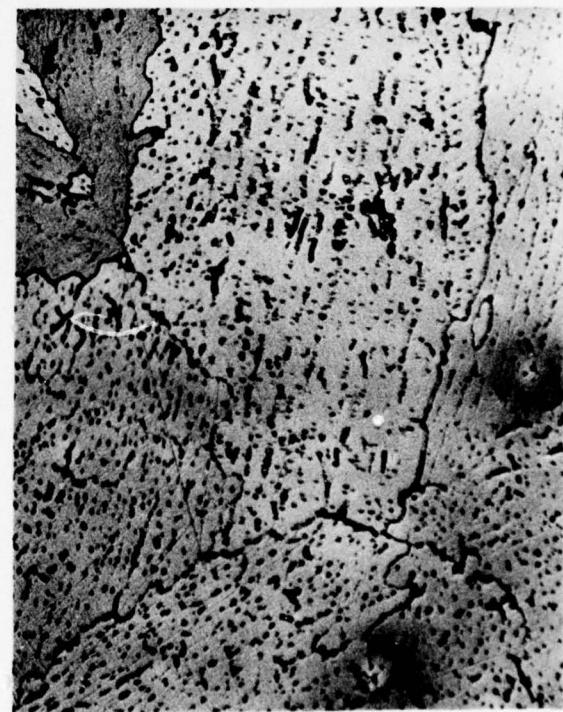
FIGURE 17. TYPICAL MICROSTRUCTURES FOR SQUEEZE CAST 7075 ALUMINUM ALLOY
AFTER SOLUTION ANNEAL.

Specimen SC-10B heat treated at 870°F for 4 hours
and water quenched.

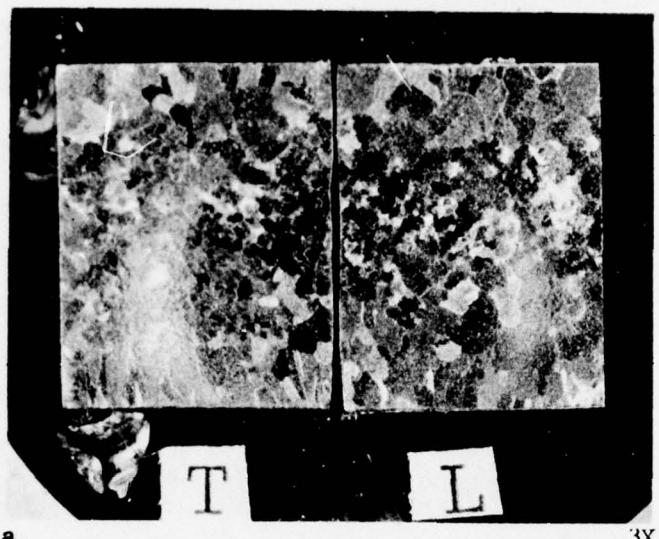
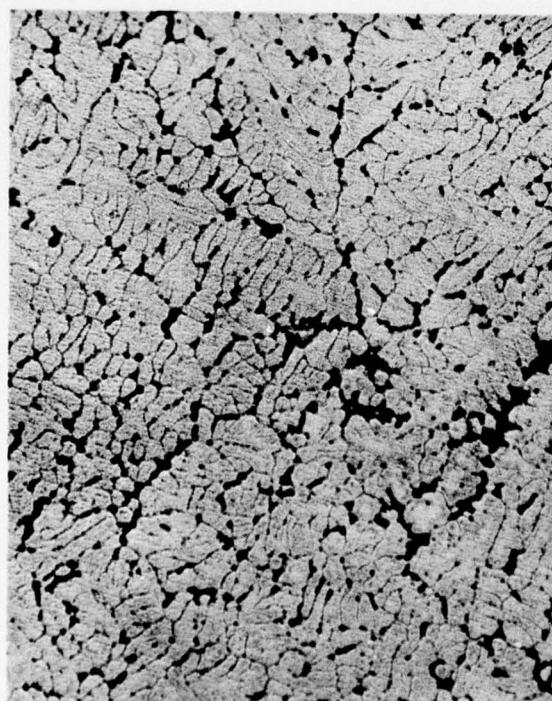
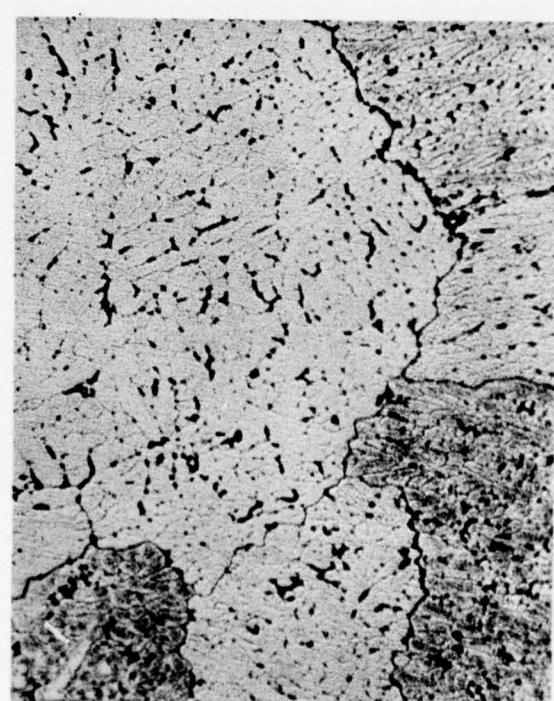
FIGURE 18. TYPICAL MICROSTRUCTURES FOR SQUEEZE CAST 7075 ALUMINUM ALLOY
AFTER SOLUTION ANNEAL.

Specimen SC-10C heat treated at 870°F for 8 hours
and water quenched.

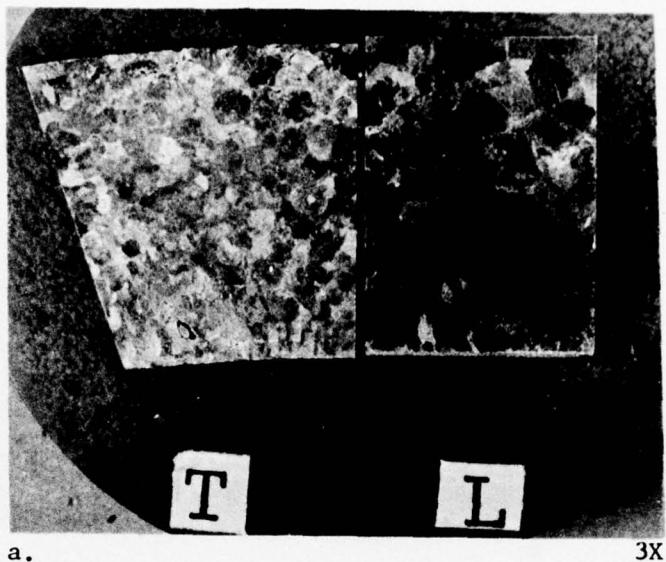
FIGURE 19. TYPICAL MICROSTRUCTURES FOR SQUEEZE CAST 7075 ALUMINUM ALLOY
AFTER SOLUTION ANNEAL.

Specimen SC-9C heat treated at 870°F for 16 hours
and water quenched.

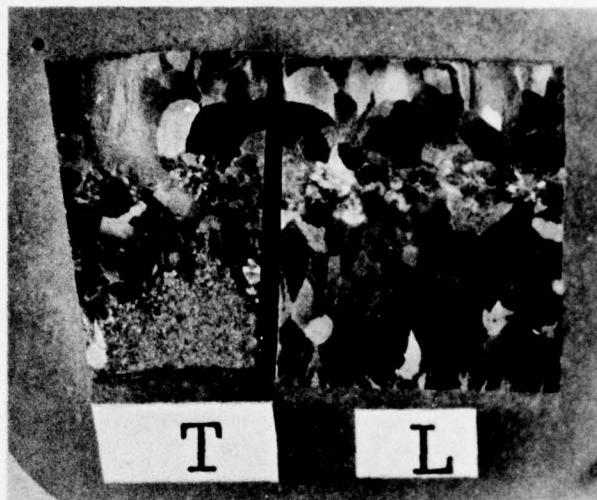
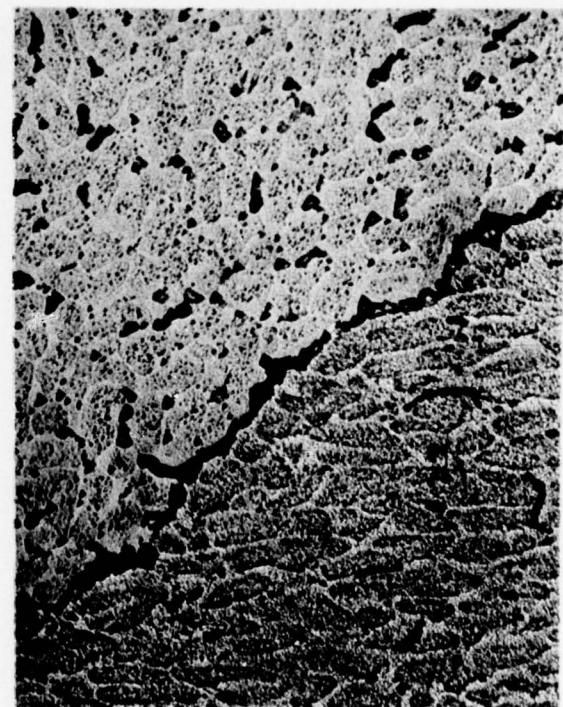
FIGURE 20. MICROSTRUCTURE OF SQUEEZE CAST 7075 ALUMINUM ALLOY AFTER
SOLUTION TREATING AND PRECIPITATION HARDENING.

Specimen SC-10BB solution treated at 870°F for 4 hours
and precipitation hardened at 250°F for 24 hours.

(1) 870°F/4 hrs. + 250°F/24 hrs. (SC-10BB): Some prior cast structure was still evident. Grain boundary phases were present. Uneven etching behavior was noted. A surface contamination in the form of an equiaxed grainy layer was found on the inside edge of the longitudinal section.

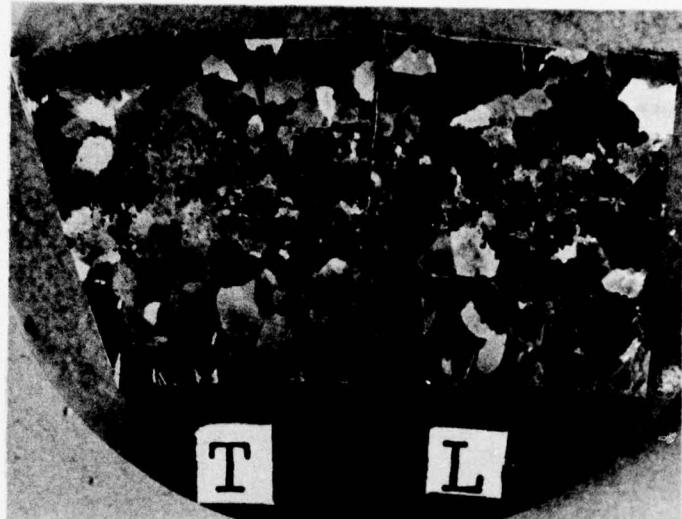
FIGURE 21. MICROSTRUCTURE OF SQUEEZE CAST 7075 ALUMINUM ALLOY AFTER
SOLUTION TREATING AND PRECIPITATION HARDENING.

Specimen SC-10CC solution treated at 870°F for 8 hours
and precipitation hardened at 250°F for 24 hours.

(2) 870°F/8 hrs. + 250°F/24 hrs. (SC-10CC): Some retention of cast structure observed. Subgrain and grain structures did not etch uniformly. A zone of heavy precipitates was found at the inside edge of the transverse section; gross segregation was also noted.

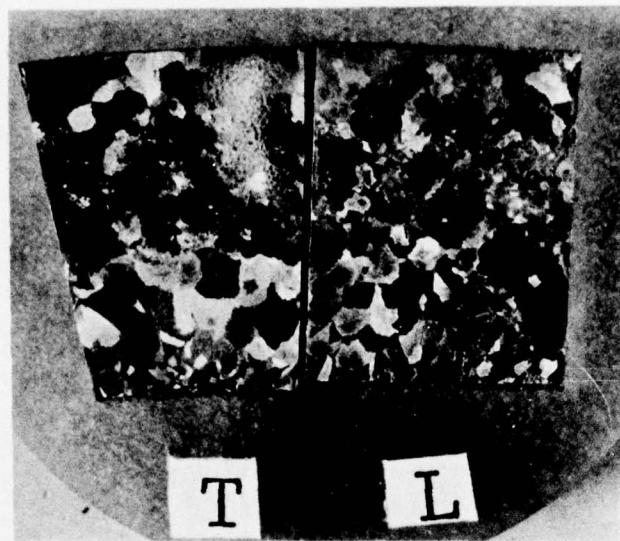
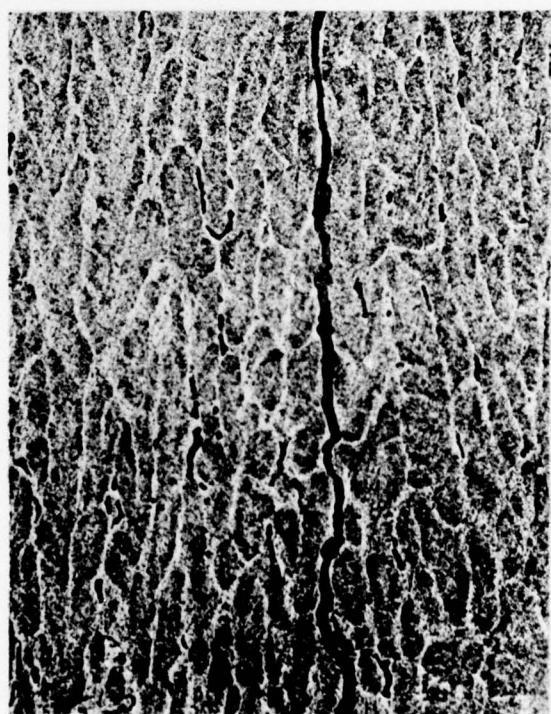
FIGURE 22. MICROSTRUCTURE OF SQUEEZE CAST 7075 ALUMINUM ALLOY AFTER
SOLUTION TREATING AND PRECIPITATION HARDENING.

Specimen SC-9CC solution treated at 870°F for 16 hours
and precipitation hardened at 250°F for 24 hours.

(3) 870°F/16 hrs. + 250°F/24 hrs. (SC-9CC): Heavy coring or chemical segregation was noted. Some precipitates were found in structure. This structure was considerably different than the other precipitation hardened structures.

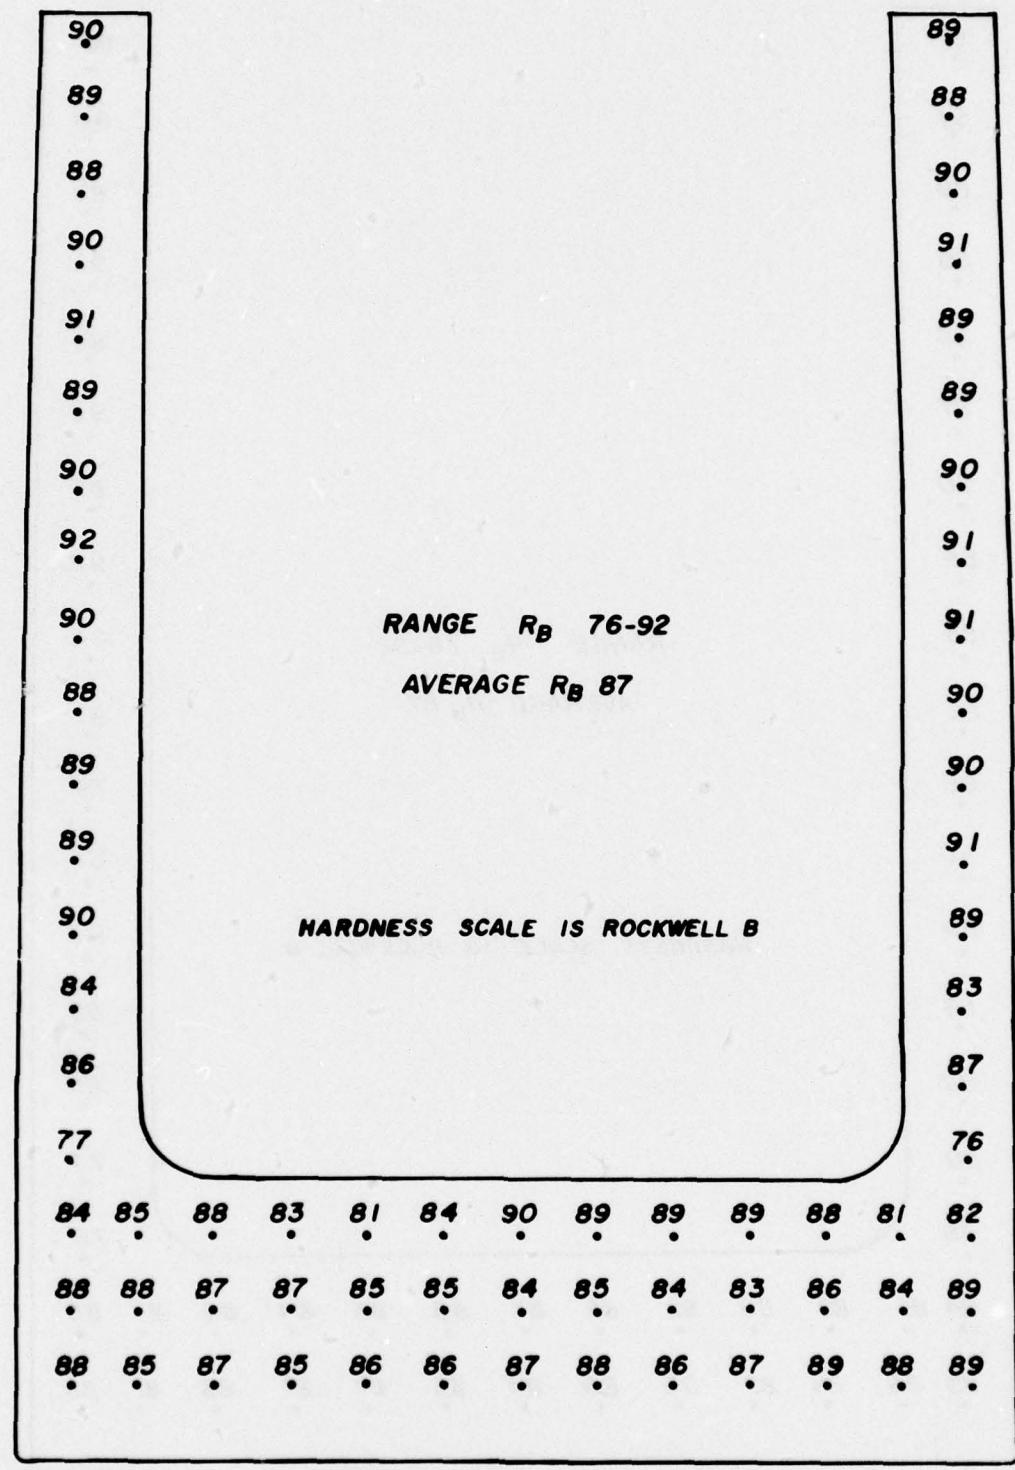
FIGURE 27. HARDNESS PROFILE FOR LONGITUDINAL SECTION FROM SQUEEZE CAST 7075-T6 ALUMINUM CYLINDER SC-9.

Hardness data were obtained for each heat treated casting using the reverse side of the macrostructure specimens. Hardness measurements were made at 1/2-inch intervals along the centerline of the sidewalls and at several locations across the base. These data are presented in Figures 27 and 28. Average hardnesses for both sections are on the low end of the typical hardness range for wrought 7075-T6 alloy (R_B 85-95). The wide variations in hardness values and the lowness of the values is probably the result of the porosity, cracking, large grain size, and chemical composition variations previously noted. Porosity and cracking contribute to erratic hardness values; large grain structures are softer than fine grain structures for a given composition; zinc, copper, and magnesium are principal solutes in the precipitation hardening reactions and reduced levels of copper and magnesium would inhibit precipitate formation. Optimization of the fabrication processes and the alloy composition should increase the hardness levels of that of the wrought material and reduce the variability.

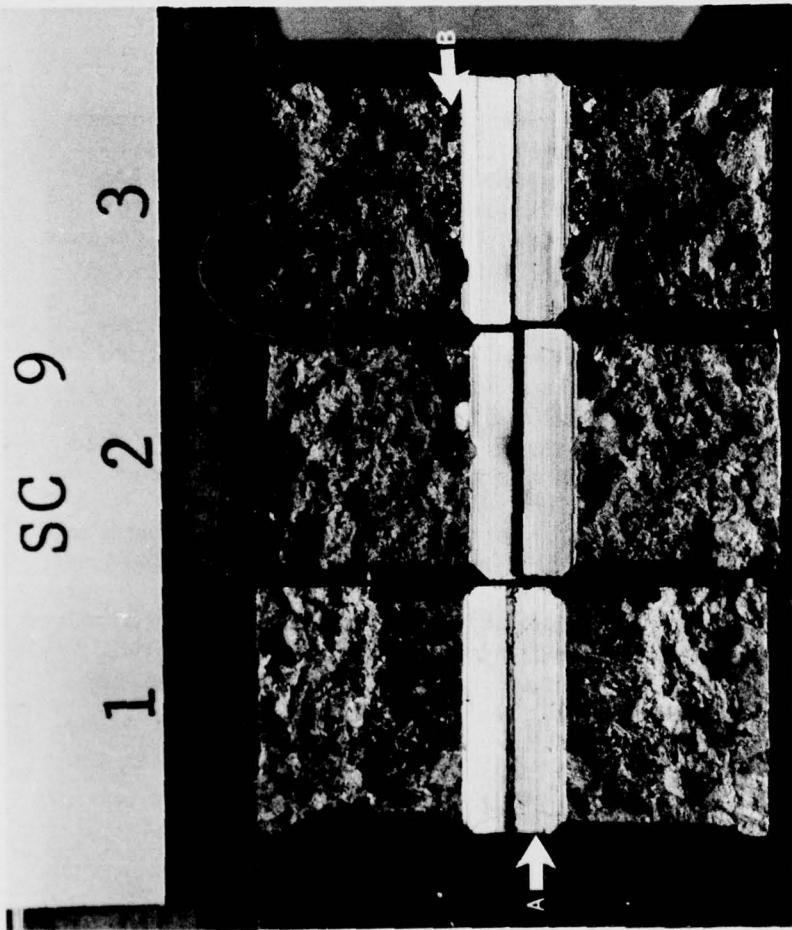
FIGURE 29. FRACTURE APPEARANCE OF NOTCHED BEND BARS FROM SQUEEZE CAST 7075-T6 ALUMINUM CYLINDER SC-9.

Figures 29 and 30 show the fracture appearance of the broken bend bar specimens. It can be seen that only specimen SC-10-1 had a uniform fatigue precrack and that, contrary to pretest inspection, specimen SC-9-1 had no fatigue precrack.

- a - major machined notch
- b - fatigue precrack

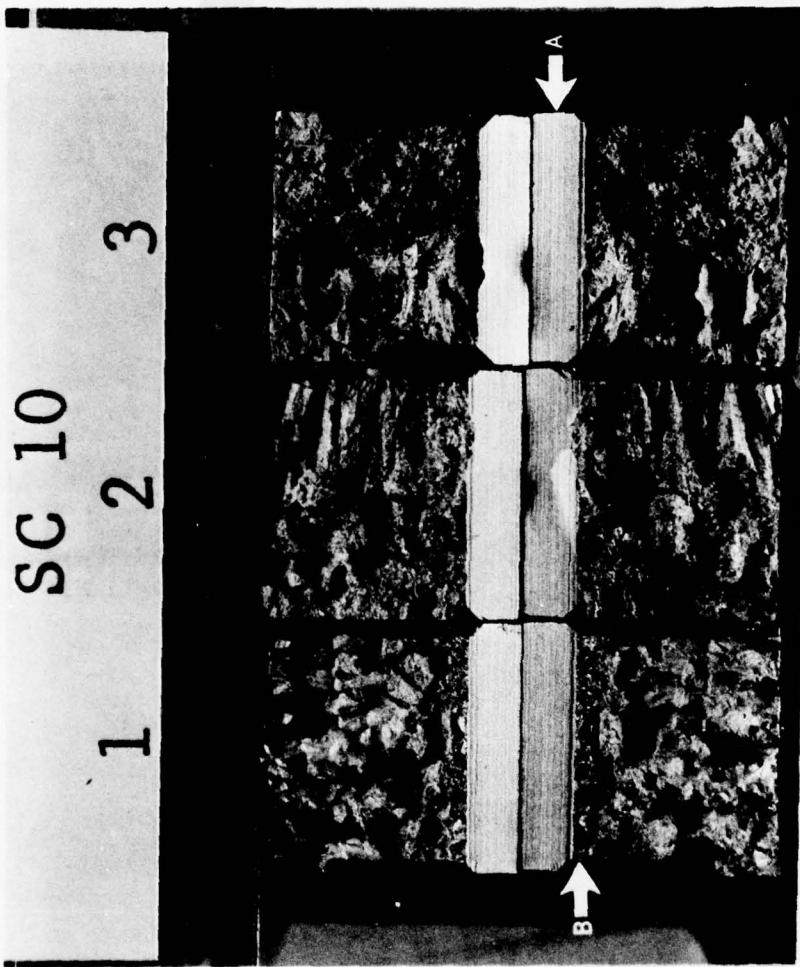
FIGURE 30. FRACTURE APPEARANCE OF NOTCHED BEND BARS FROM SQUEEZE CAST 7075-T6 ALUMINUM CYLINDER SC-10.

- a - major machined notch
- b - fatigue precrack

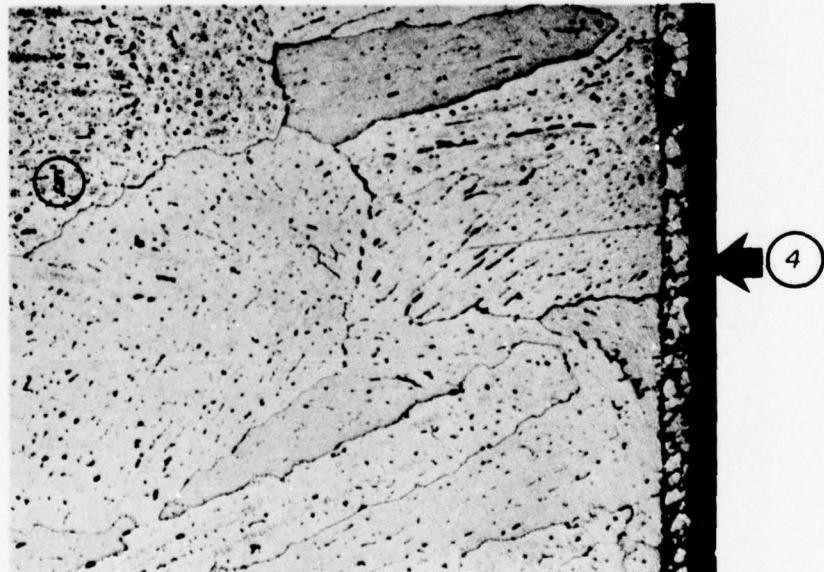
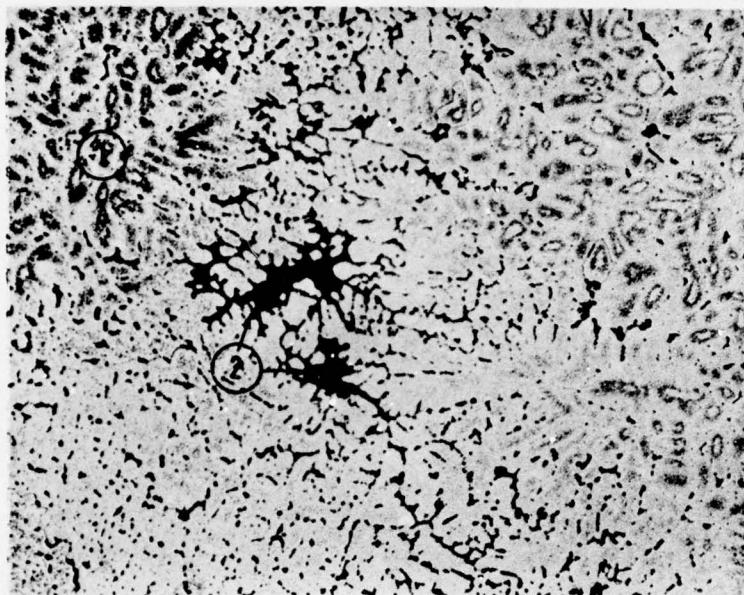
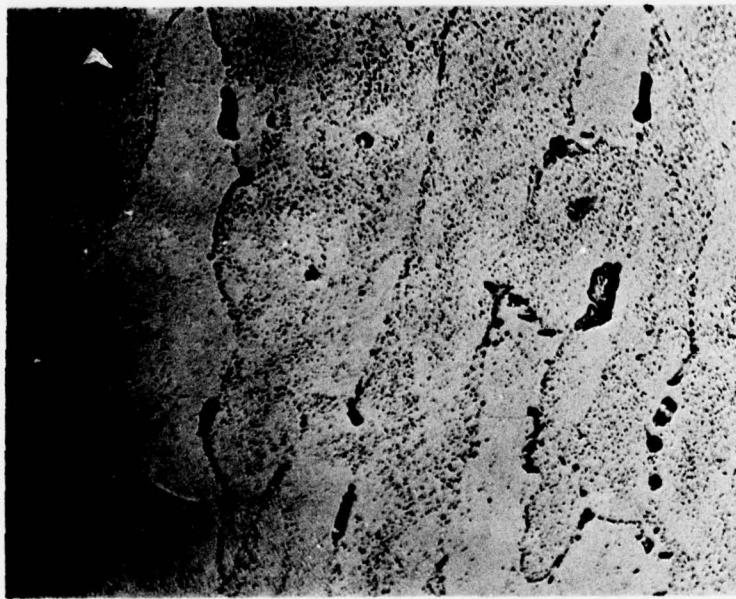
FIGURE 32. REPRESENTATIVE MICROSTRUCTURAL FEATURES OF SQUEEZE CAST
7075-T6 ALUMINUM CYLINDER SC-9.

In addition to the large grain size, this investigation also revealed the formation of subgrains, the remains of the cored structure due to chemical segregation during solidification, both general and boundary precipitates, and a copper colored deposit at some of the grain and subgrain boundaries. The inside surface of cylinder SC-9 had a distinctive fine-grained layer which was believed to be oxide contamination. An indication of metal flow in the base during the "squeezing" operation was found in cylinder SC-10. These microstructure details are illustrated in Figures 32 and 34.

a. Transverse 100X
ID Surface Layer (1), Substructure (2),
and Coring (3).

b. Longitudinal 100X
ID Surface Layer (4) and Coring (5)

Coring (1) and Copper Colored Deposit (2)

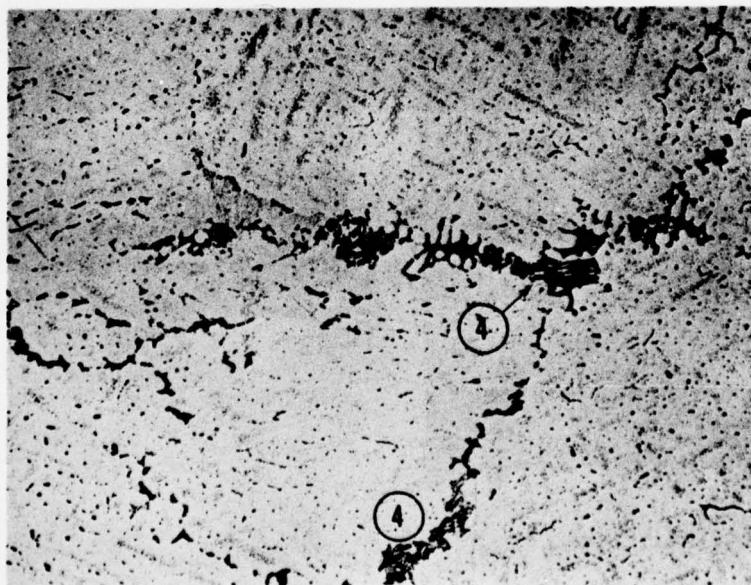
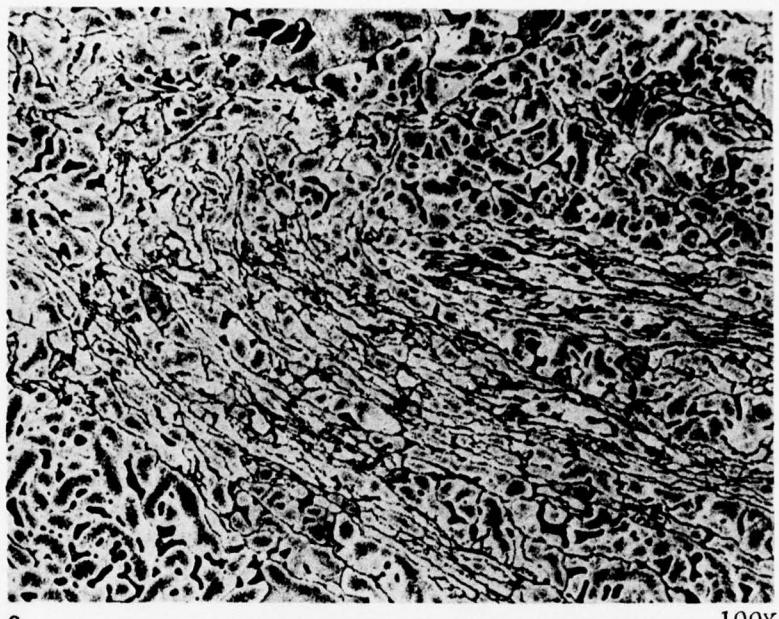
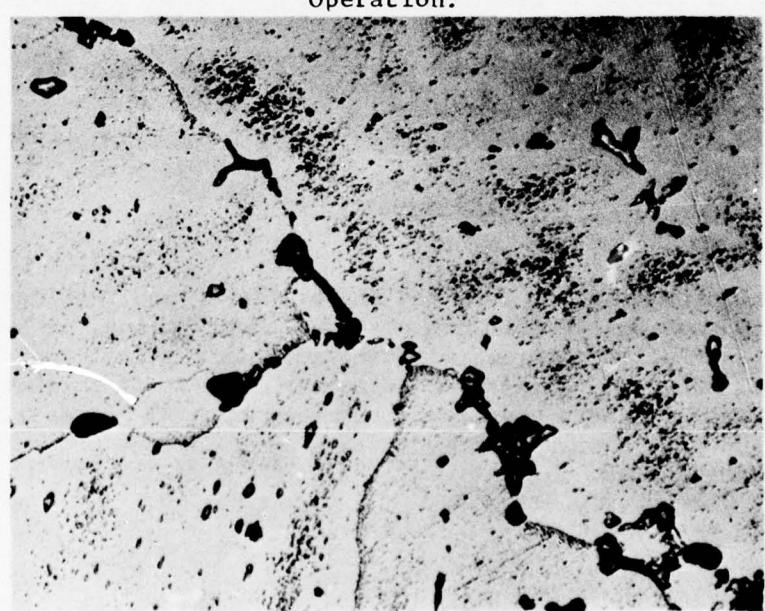
FIGURE 34. REPRESENTATIVE MICROSTRUCTURAL FEATURES OF SQUEEZE CAST
7075-T6 ALUMINUM CYLINDER SC-10.

Substructure (1), Coring (2), and Residual
Cast Structure (3).

c. 100X
Metal Flow in Base Section From "Squeezing"
Operation.
